RESPONSE OF ARCHING WALLS AND DEBRIS
FROM INTERIOR WALLS CAUSED BY BLAST
LOADING

URS Research Company

Defense Civil Preparedness Agency

February 1975

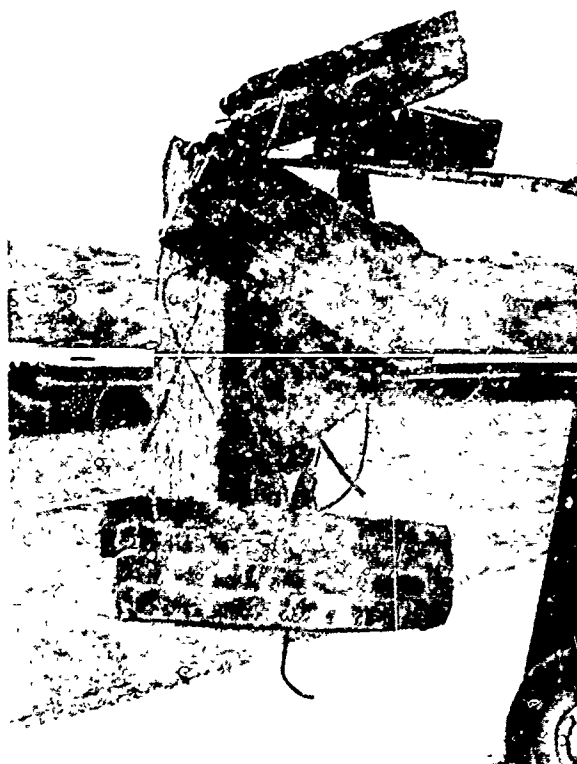
The analysis of preloading of walls given in Ref. 5 indicates that its effect is to increase wall resistance some 10 to 20%. However, even without this added effect, the threshold failure pressure for the reinforced brick walls (below 2 psi, but above 1 psi) is larger than the apparent threshold value (0.75 psi) for the unreinforced walls. In neither test did any of the reinforcing rods fail, though they were very severely strained, and the individual pieces of debris, still connected to each other, were quite large (see Fig. 2-3). Additional test details are given in Appendix A.

Fig. 2-3. Debris from Wall Number 99.

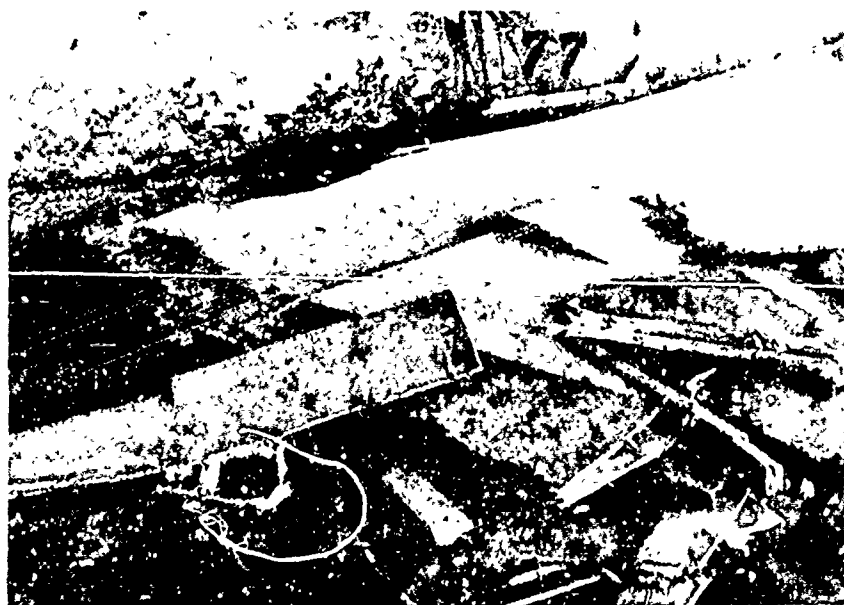
Fig. 3-2. Posttest Photographs, Wall 102.

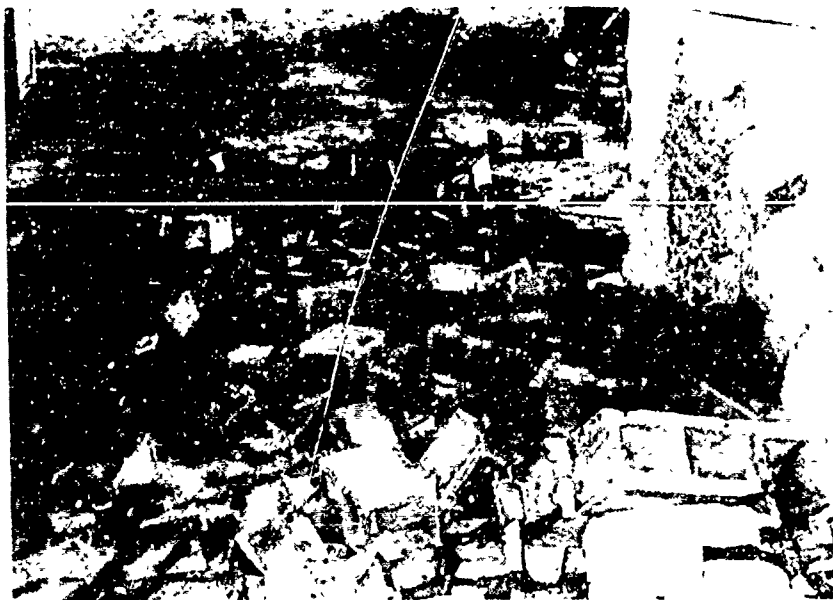
Fig. 3-10. Posttest Photographs, Wall Number 116.

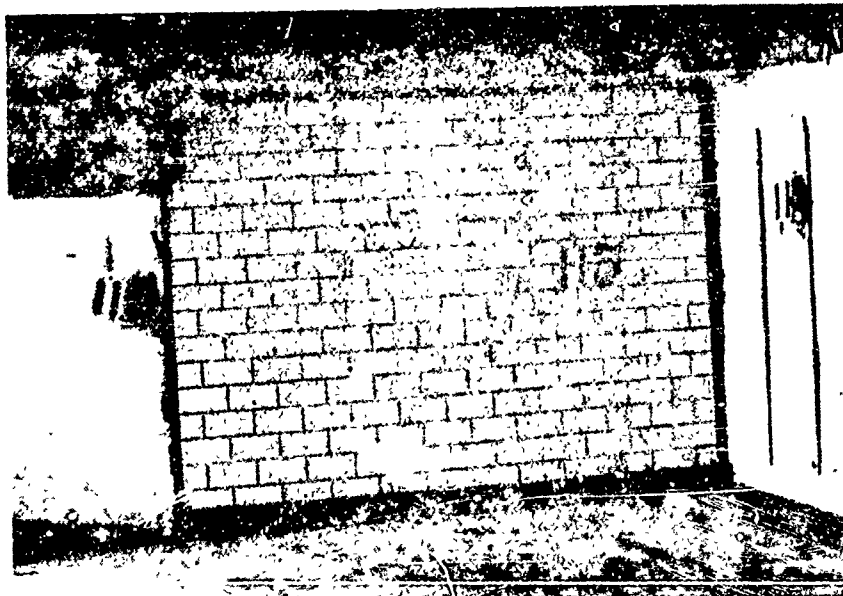
Fig. 3-15. Pretest Photograph, Wall Number 119.

Wall 120 (tested at a peak incident overpressure of 3.9 psi) also cracked below center and would probably have failed the same as 119. As this crack opened up, however, the upper part of the wall was forced up more than four inches and struck the top of the tunnel which caused a diagonal crack in the top section. Very little further break-up occurred as the top section traveled airborne most of the way across the casemate. It attained a final velocity of about 44 ft/sec. Posttest photographs of the debris of these walls is presented in Fig. 3-16 and Fig. 3-17 and the displacement as a function of time data obtained from the motion picture film is presented in Fig. 3-18.

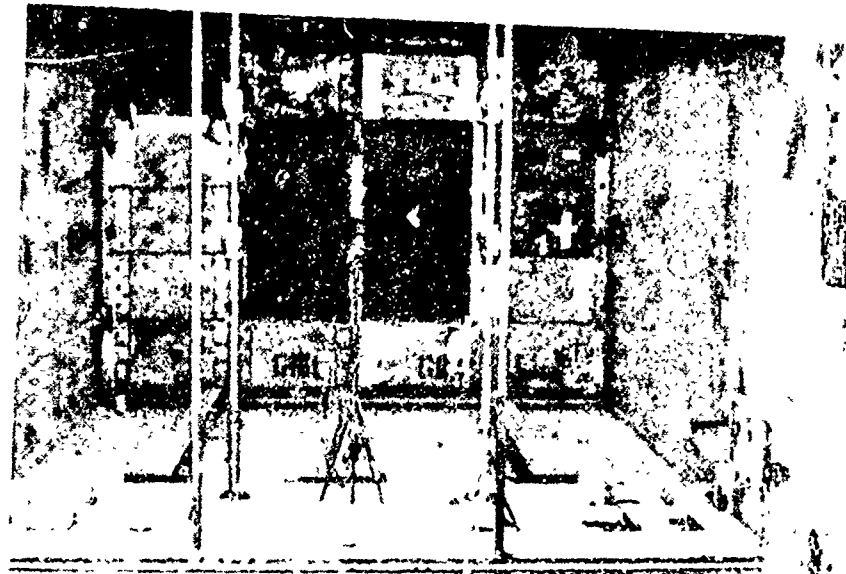
Fig. A-2. Photograph of Nonfailing Wall With Window Opening.

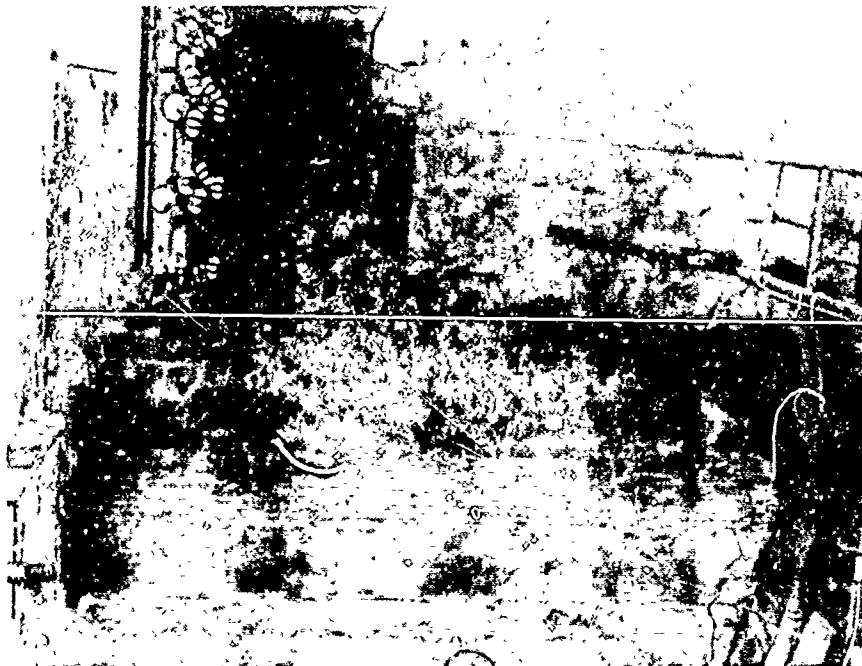
One test was conducted on this wall using two 60-ft strands of Primacord which gave an average peak incident overpressure of 2.3 psi. The wall failed, with the three crack gauges indicating crack times of 28.6, 35.2, and 26.5 msec. The longest crack time, 35.2 msec, was from a crack at the center of the wall. Analysis of the motion picture films indicated that a horizontal crack about 2/3 of the way up the wall appeared first, with additional cracks appearing much later 1/3 of the way up the wall. The major part of the debris from this test landed within the first thirty feet with only a few pieces landing beyond that distance. The location and size of the debris fragments can be seen in the photographs in Fig. 97-1 and Fig. 97-2.

Fig. 97-1. Pre and Posttest Photographs, Wall Number 97.

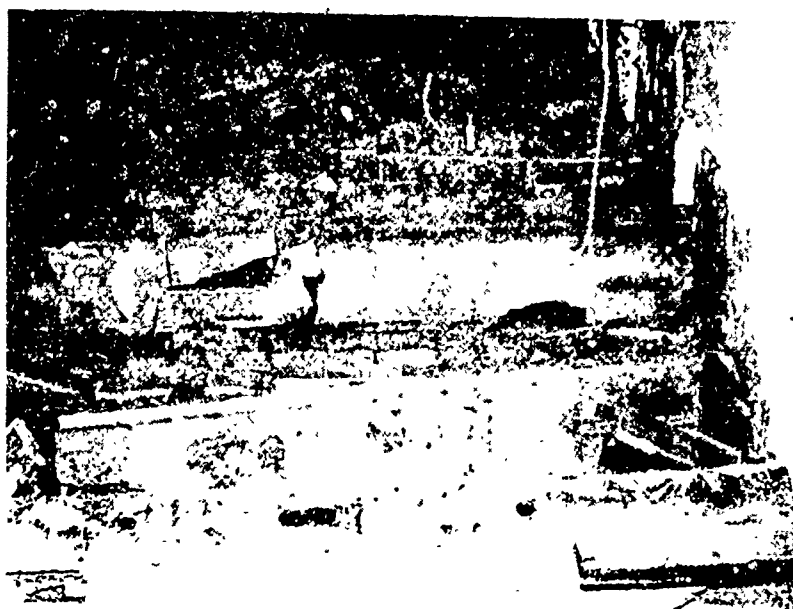
One test was conducted using two strands of Primacord. The average peak incident overpressure was 1.9 psi. The three crack gauges indicated crack times of 35.5, 32, and 39.9 msec, but they are all from a single stepped crack extending from the 19th row of bricks on one side of the wall, to the 17th row on the other. As in the previous test, essentially all the debris landed within the first 30 feet. The amount and location of the debris can be seen in the posttest photographs presented in Fig. 98-1 and Fig. 98-2. Posttest inspection also indicated numerous pieces of brick upstream from the wall's initial location which had apparently been spalled off the top edge of the wall. A number of these fragments can be seen in the photographs in Fig. 98-3.

Fig. 98-1. Posttest Photographs, Wall Number 98.

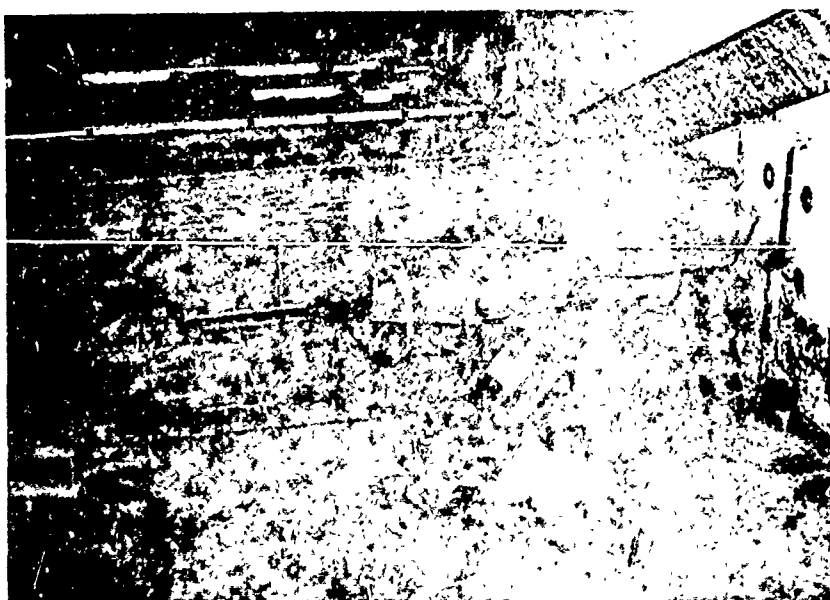
Fig. 99-1. Posttest Photographs, Wall Number 99

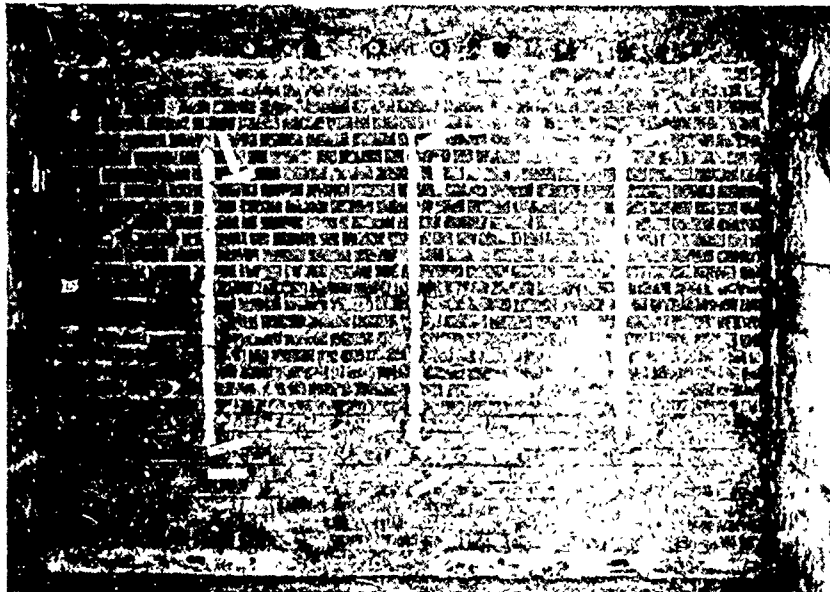
Fig. 100-1. Posttest Photographs, Wall Number 100

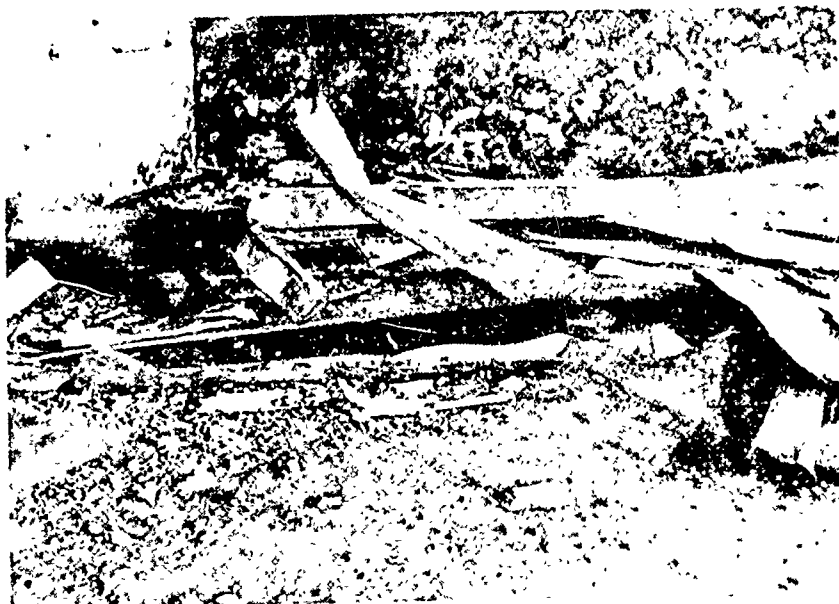
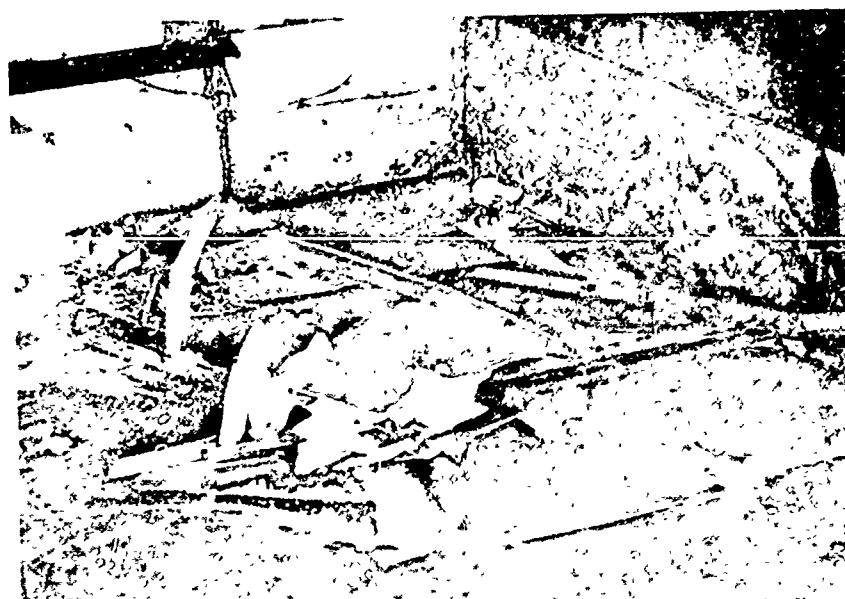
One test was conducted using four 60-ft strands of Primacord (average peak incident overpressure 3.5 psi). The wall translated down the tunnel, remaining intact until it struck the bend of the tunnel; with the exception of two vertical cracks at the first and second metal studs on one side. Then, with the exception of a few pieces of sheetrock and two perimeter metal studs, the wall debris continued until impact with the far casemate wall, a distance of approximately 87 ft from the original wall location. The type, sizes, and location of the debris can be seen in the photographs in Fig. 105-1 and 105-2. A plot of displacement as a function of time is presented in Fig. 105-3.

Fig. 105-1. Posttest Photographs, Wall Number 105.

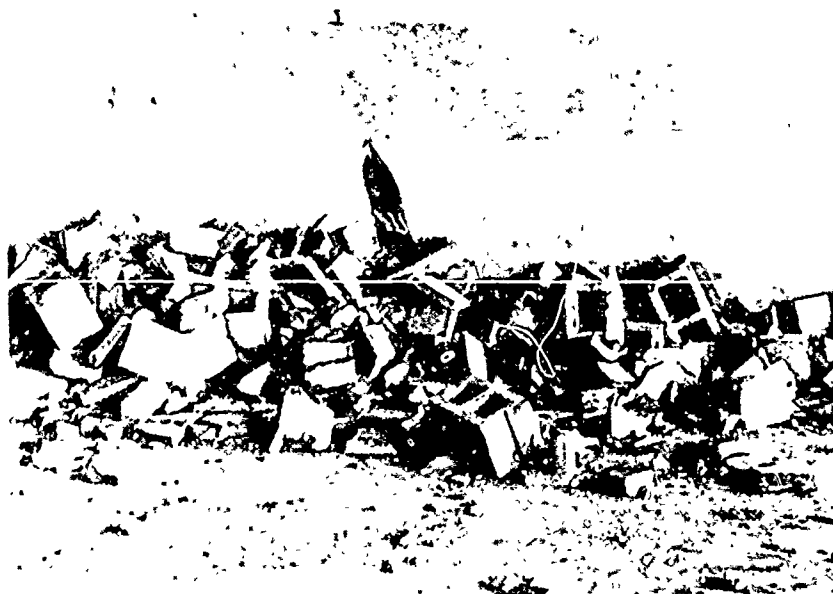
This wall was tested using five 60 ft strands of Primacord (average peak incident overpressure 3.6 psi). The initial crack was horizontal at the mortar joint between the third and fourth rows of block (the wall is eleven rows high). A second crack appeared between the fifth and sixth rows. Immediately after this, numerous cracks appeared across almost every row and the wall disintegrated. Pre and posttest photographs of the test are presented in Figs. 108-1 and 108-2. A plot of displacement as a function of time is presented in Fig. 108-3.

FIG. 104-1. Pre and Posttest Photographs, Wall Number 103.

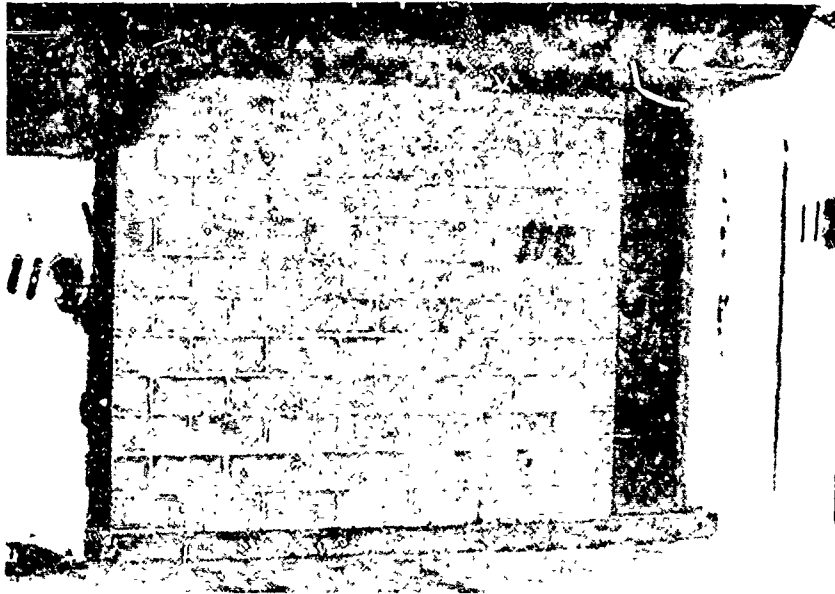
This wall was tested using five 60-ft strands of Primacord (average peak incident overpressure 3.6 psi). Two initial cracks were noted between the third and fourth rows and one between the fourth and fifth rows. The film record was badly obscured by dirt and smoke flowing through the doorway opening but as nearly as could be determined the bottom third of the wall broke into small sections and fell over and hit the floor. The top two thirds remained intact and hit the floor at a distance of 25 to 30 ft. Photographs of this wall are presented in Figs. 118-1 through 118-3. A plot of displacement as a function of time is presented in Fig. 118-4.

Fig. 118-1. Pre and Posttest Photographs, Wall Number 118.

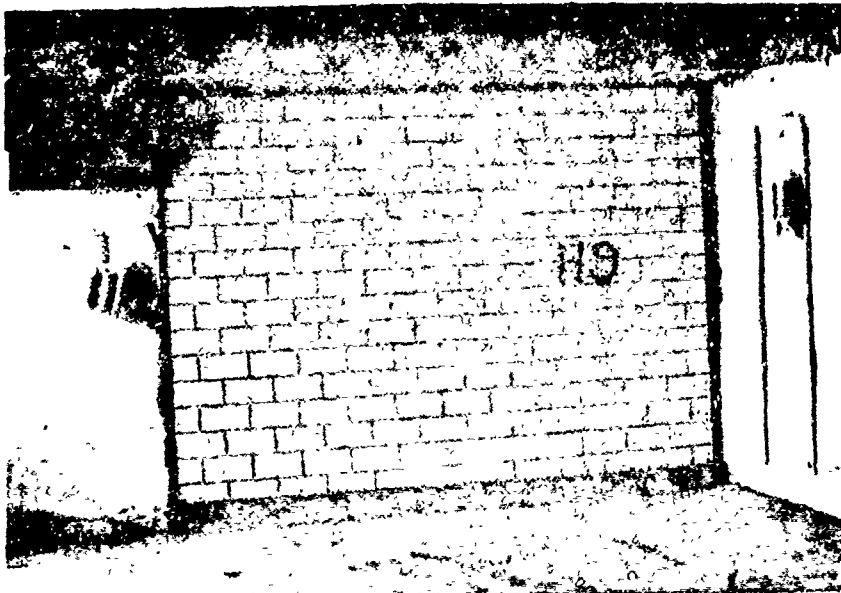
Fig. 119-1. Pre and Posttest Photographs, Wall Number 119.

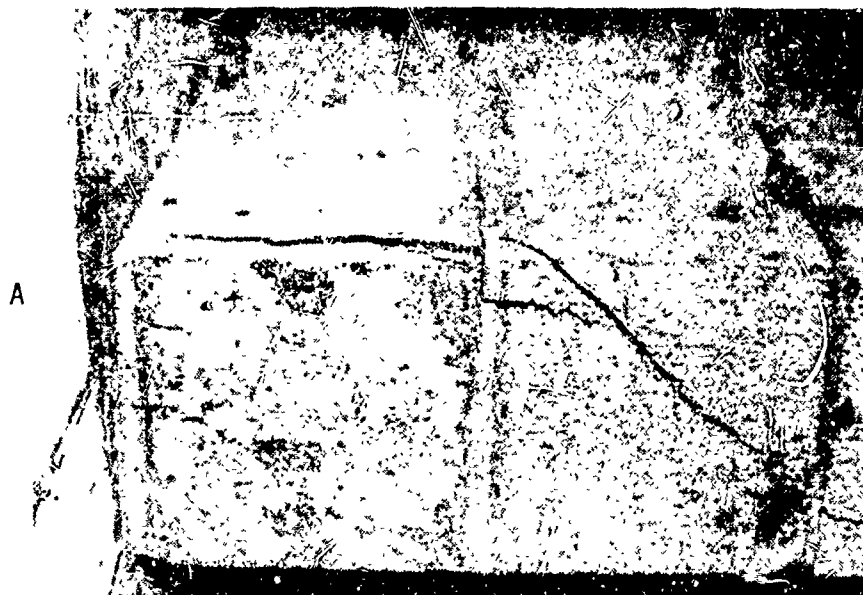
Fig. B-6. Typical Failure Concrete Arched Beam.
